# Headform to Bonnet Leading Edge

## Test Procedure

## Technical Bulletin CP 402

Implementation 1<sup>st</sup> January 2026

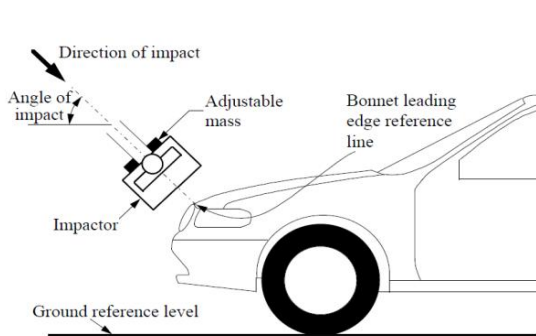
*Upper legform to bonnet leading edge test*

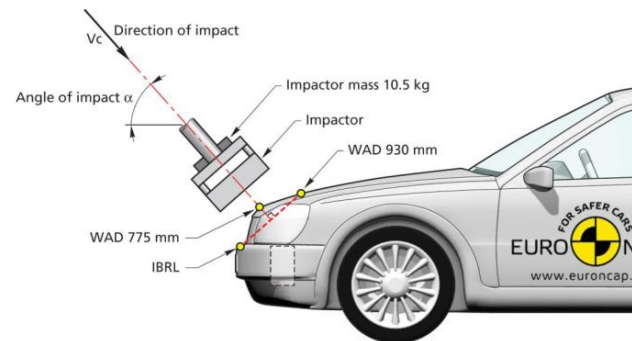
*Revised upper legform test. (Upper legform to WAD 775 mm test)*

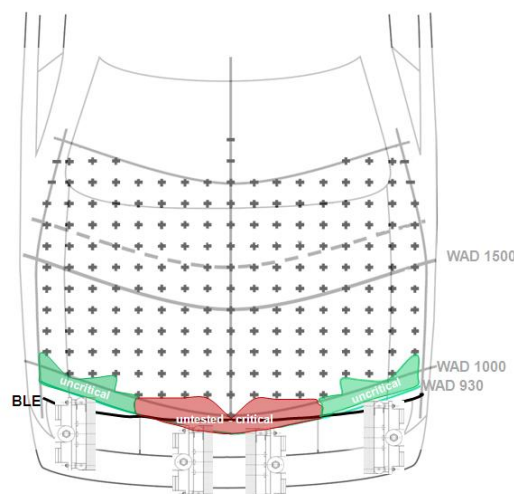
While in most cases the protection potential of the leading edge will be covered by the revised upper legform test, rare cases will still occur where the bonnet leading edge reference line is precisely located in the area between the wrap around distances 1000 mm (forward limitation of the child headform test zone) and 930 mm (location of the upper load cell of the upper legform impactor, the upper limitation of the new upper leg test), an area which by definition is untested (Note: according to the new procedure, regardless the vehicle front geometry, at least the area between WAD 1000 mm and WAD 930 mm at vehicle longitudinal centerline will not be tested anymore. Due to the GRID definition, this untested area is getting larger moving laterally along the vehicle in outboard direction):

BLE located between WAD 1000 and WAD 930 => no test

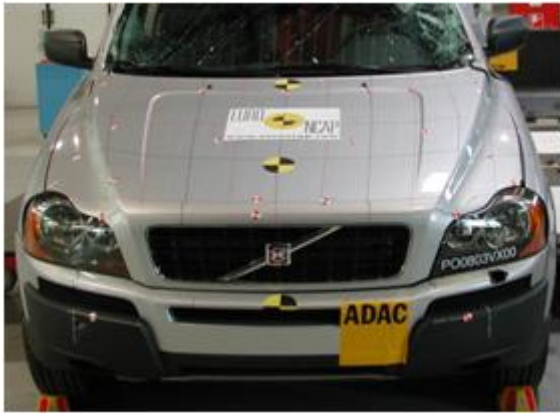
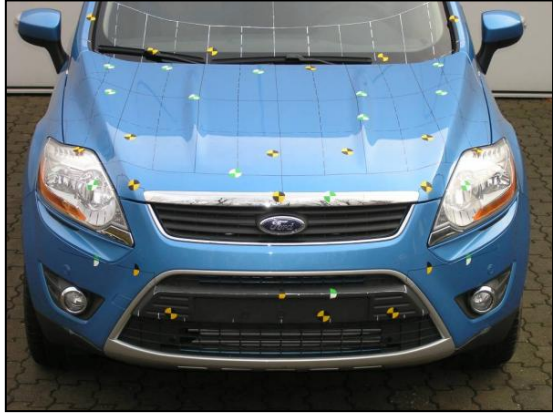
Examples of vehicles where the BLE located between WAD 1000 and WAD 930

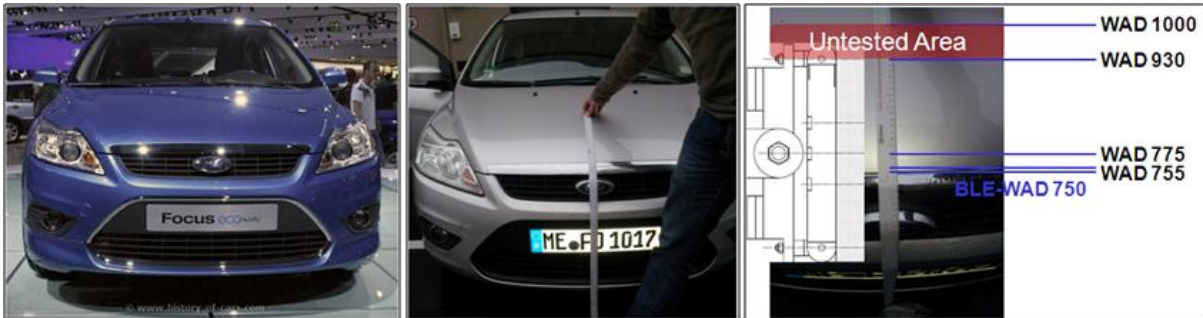
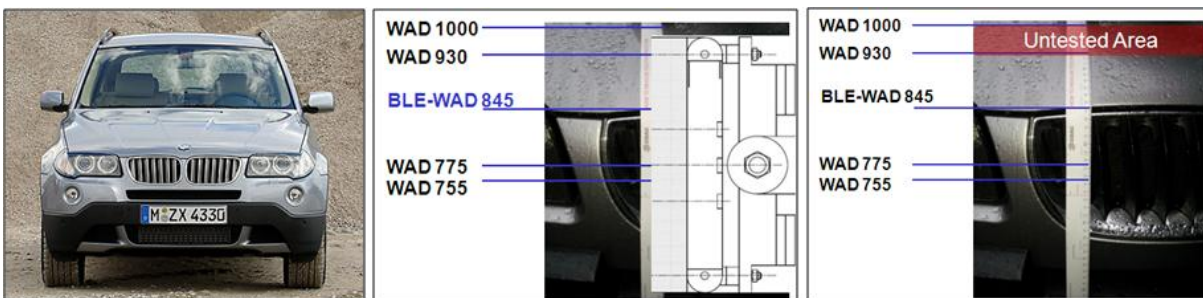
The area between WAD 1000 mm and WAD 930 mm is assumed to be uncritical when no hard structures / injury causing vehicle components are located under the surface.

However, if hard structures are located in this untested area (as it can be assumed for the bonnet leading edge and its periphery) the area should be regarded being critical in terms of VRU protection.

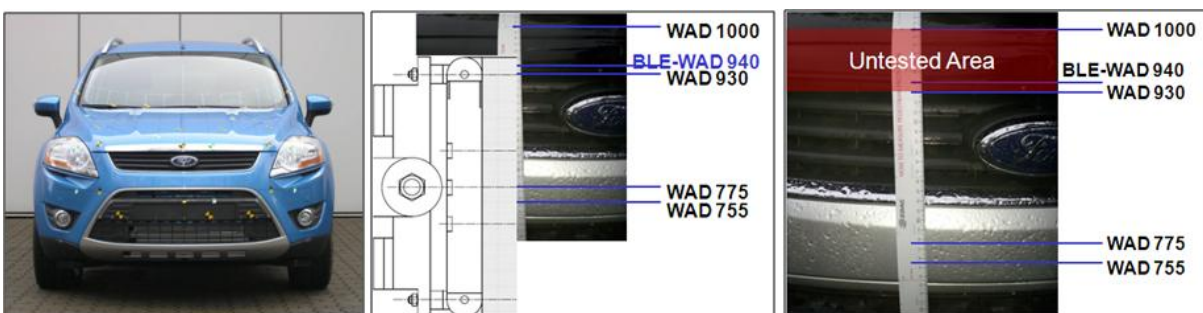
The headform to bonnet leading edge test, defined in the Technical Bulletin, is meant to assess the injury risk of the bonnet leading edge during a vehicle impact against a vulnerable road user in case of not being considered within the revised upper legform test. The headform to bonnet leading edge test is to be carried out in all cases where the bonnet leading edge reference line is located between WAD 1000 mm and WAD 930 mm and thus not being tested by means of the revised upper legform test.

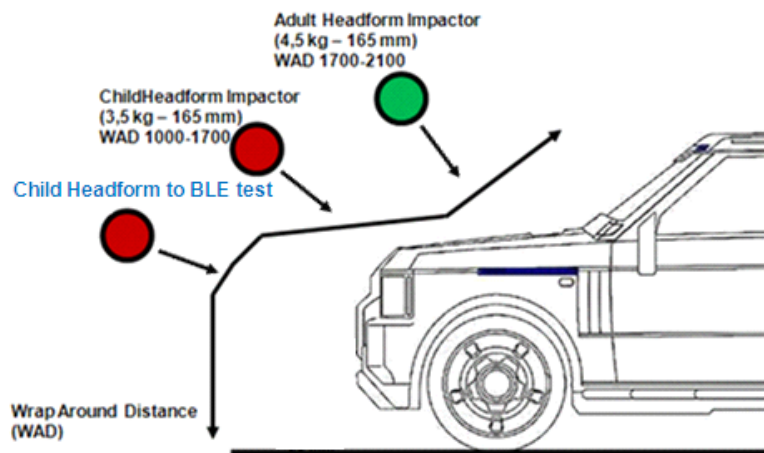
For the vertical longitudinal plane of any upper legform grid point determined in paragraph 3.11 of the pedestrian testing protocol where the bonnet leading edge reference line is located between WAD 930 mm and WAD 1000 mm, an additional test with the child headform impactor will be performed at the intersection of the vertical longitudinal plane with the bonnet leading edge reference line at an impact speed of 40 km/h under an impact angle of  $20^\circ \pm 2^\circ$  to the Ground Reference Level.

The result of this test will be monitored against a HIC value of 650. Where a 'poor' test result has been achieved, Euro NCAP may choose to comment on this alongside the normal pedestrian protection score. The results of these tests will NOT be reflected in the pedestrian protection score or any other part of the overall assessment.
